## DDASaccident443

# DDAS Accident Report

<b>Report date:</b> 28/12/2007	<b>Accident number:</b> 443
<b>Accident time:</b> 10:40	<b>Accident Date:</b> 30/10/2006
<b>Where it occurred:</b> MF# AF/0308/01648/108 Bakhshikhail Village, Bagram District, Parwan Province	<b>Country:</b> Afghanistan
<b>Primary cause:</b> Management/control inadequacy (?)	<b>Secondary cause:</b> Field control inadequacy (?)
<b>Class:</b> Excavation accident	<b>Date of main report:</b> 19/11/2006
<b>ID original source:</b> SHA-333, OPS- 27/445/06	<b>Name of source:</b> UNMACA
<b>Organisation:</b> [Name removed]	
<b>Mine/device:</b> PMN AP blast	<b>Ground condition:</b> building rubble dry/dusty rocks/stones
<b>Date record created:</b> 28/12/2007	<b>Date last modified:</b> 28/12/2007
<b>No of victims:</b> 1	<b>No of documents:</b> 3

## **Demining Investigation Report**

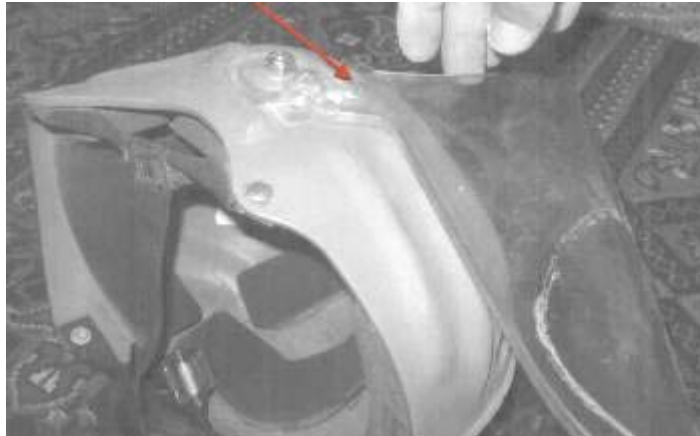
Equipment/property damage: Trowel was broken. [Visor was also broken.]

[The type of visor photographed often breaks in the place arrowed – even when not involved in a blast event.]

tool” despite the Bol’s opinion to the contrary. Its fragments could have caused severe injury. The visor also broke (this visor type frequently does in a blast) and it is uncertain whether this contributed to the victim’s eye injury.

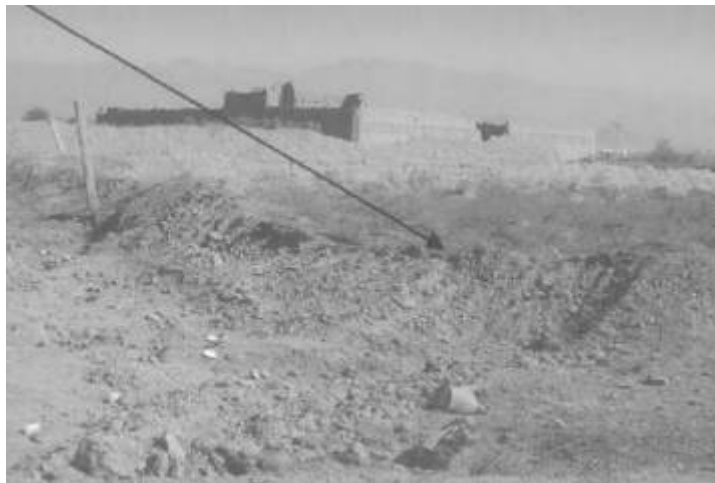
[A photograph of the site shows rocky ground (including rocks from the ruined wall) and no vegetation. The preparatory “raking” of the backhoe is clearly visible. There is inadequate area marking with no lane visible and no easy way to see what land has been cleared. The arrow points to the site of detonation.]

2. A ruined wall existed near the accident point, the machine should firstly had removed the soil of this wall then ripped the original surface of the ground with 30 cm depth, but as we saw the backhoe team has considered the surface of the ruined wall as original surface of the ground, so, they have ripped just surface of the ruined wall.

3. The ripping depth of the ground surface near the accident point was reduced from 30 cm to 10 cm. Reducing the ripping depth to 10 cm; may has changed the mine direction or broken it which makes the mine further sensitive.

1. The [Demining group] operation section should make at least one qualified deminer of each team subject to TL courses.
2. Just ripping the site with backhoe machine is not enough for reducing the risk, but further exceeds the risk. The backhoe should remove the ripped soils to a cleared area, the removed soil should be visual checked by the backhoe section leader and then be checked by deminers with detector.

3. The backhoe operator should maintain the 30 cm depth while ripping the site, team leader and the relevant section leader should control that the required depth is maintained.

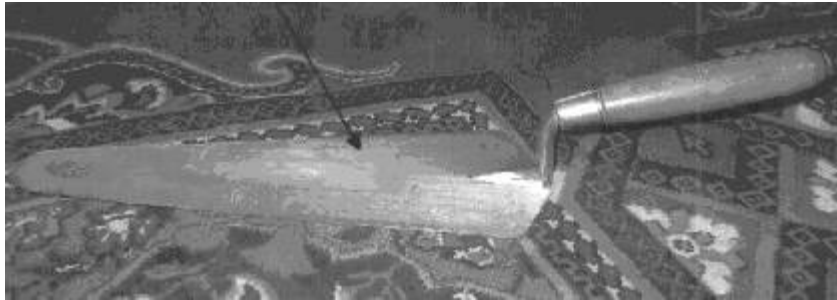
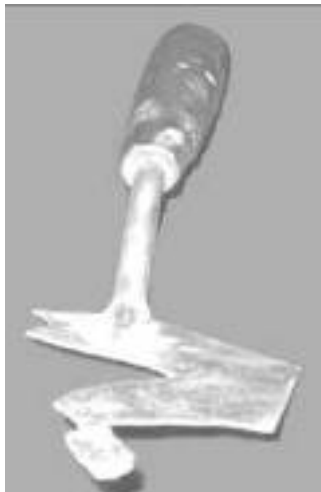
The inadequate equipment listed under "Notes" refers to the deminer's hand-tool and visor. The hand-tool was a plasterer's trowel that shattered dangerously. It was not an "appropriate

The pictures show the trowel before and after the initiation. The material shatters in a blast and so introduces a high risk of fragmentation injury to a blast event.
